TEST REPORT

Manufacturer: Milerd Electronics

Comparative test before and after using the Milerd Detoxer based on:

Report 21-17476

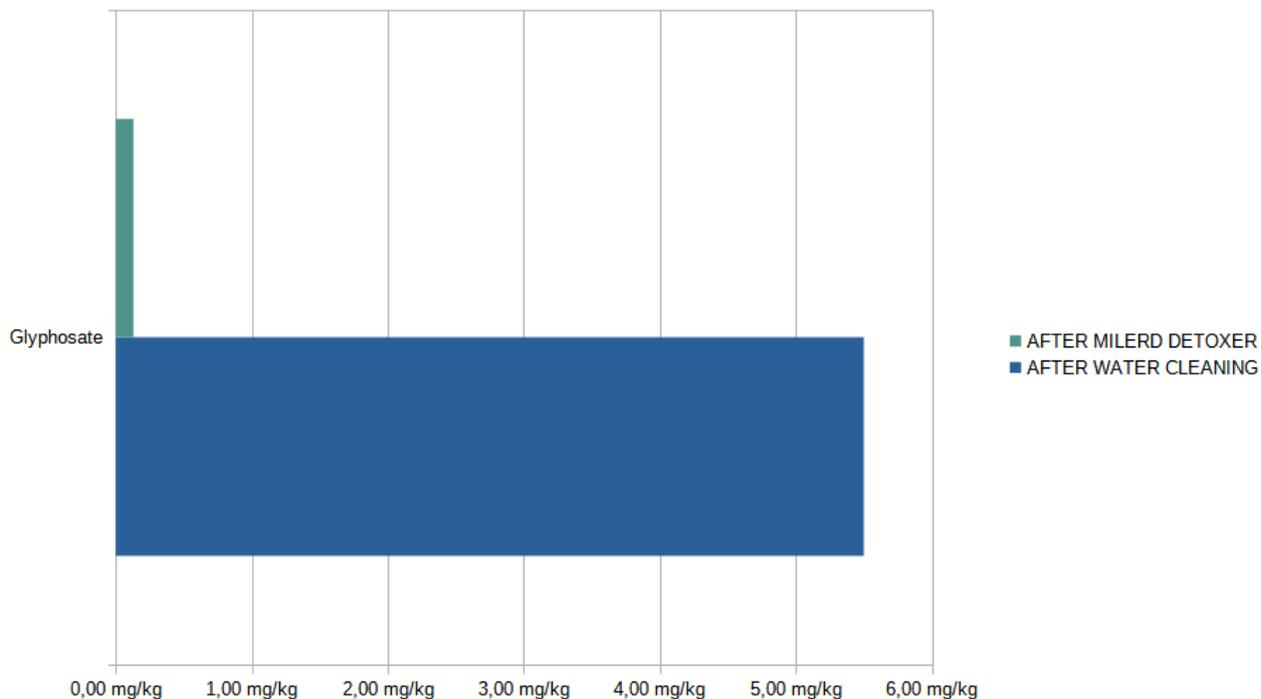
Glyphosate content in buckwheat:

Parameter	Method	Reduction after	Groats after water cleaning	Groats after Milerd Detoxer
Glyphosat	INTNLCH039 - LC-MS/MS	97.63%	5,5mg/kg	0,13mg/kg

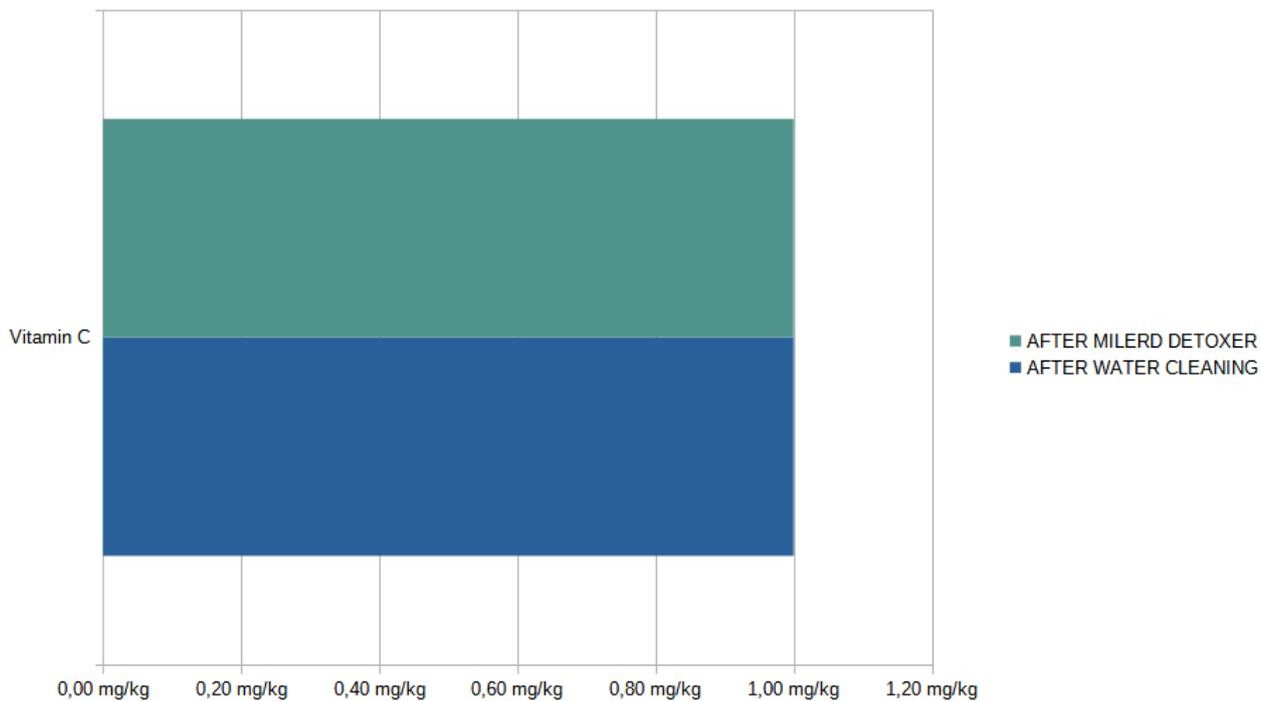
Vitamin C concentration before and after use Milerd Detoxer:

Parameter	Method	Concentration after Milerd Detoxer	Concentration after water cleaning	Difference
Vitamin C	SLMNLCH011 – SLMB, HPLC-UV	1mg/100g	1mg/100g	0%

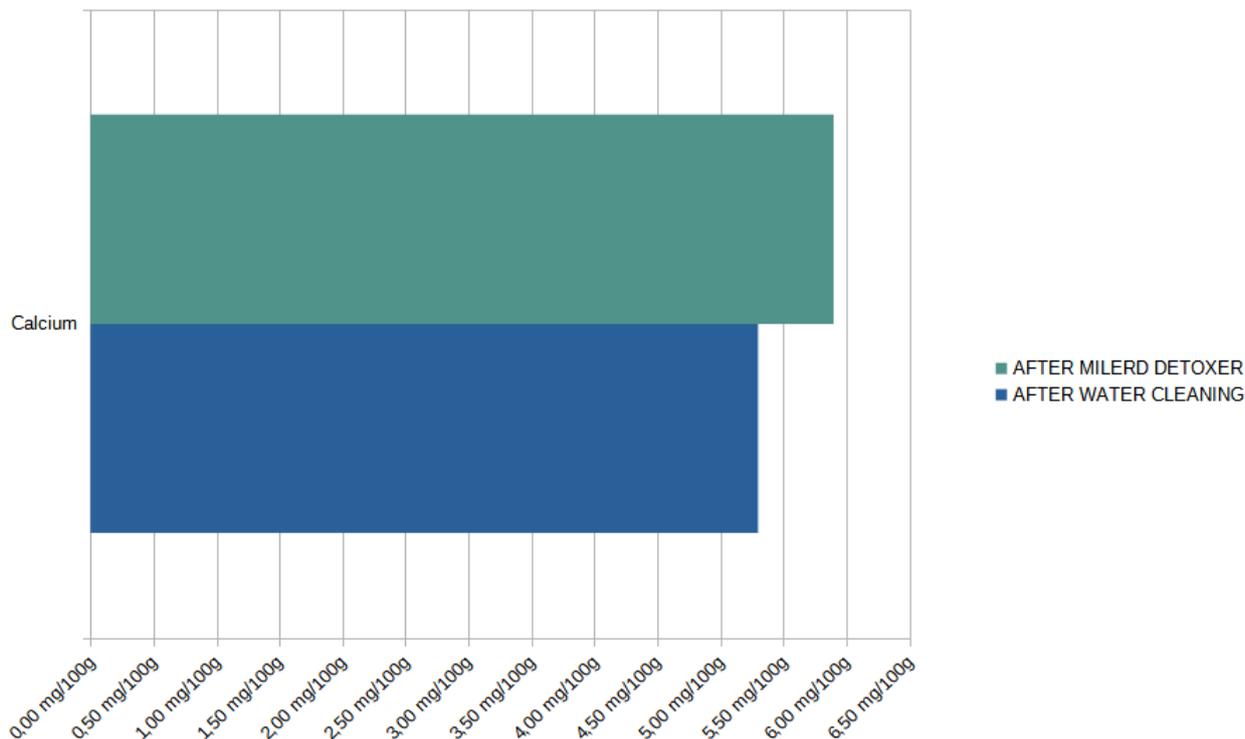
Calcium concentration before and after use Milerd Detoxer:

Parameter	Method	Concentration after Milerd Detoxer	Concentration after water cleaning	Difference
Calcium	INTNICP001 – UFAG, ICP-OES	5,90mg/100g	5,30mg/100g	+10% after Milerd Detoxer
